First Cloth Hall (465922)

First White Cloth Hall, 98 – 101 Kirkgate, Leeds LS2

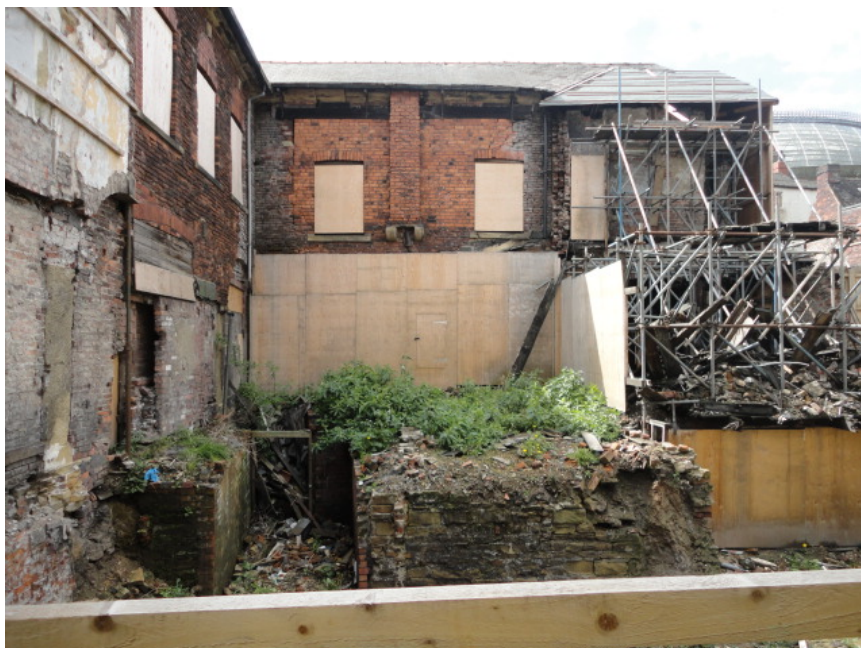
Two thirds of the building currently survives, while the west wing has been demolished. The original structure of Thoresby's 'stately hall for White Cloths built upon Pillars and Arches in the Form of an Exchange with a Quadrangular Court within' can now be seen. The three ground floor arches at the back of the courtyard have been boarded up, while the heads and pillars of what were once open ground floor arches can be seen in the wall of the east wing. The round headed windows at first floor level can be seen in the east wing while those at the rear of the courtyard have gone. The roof trusses of the demolished west wing have been put in storage as have the bricks and masonry of the demolished wing. Some attempts at weatherproofing the building have been made but it is still in a very critical state.

The building is in a critical state, the ground floor is covered by a hoarding, and the entire building is covered in scaffolding. The majority of windows are missing, and any wood that remains is

almost rotted away. The gutters are leaking and the building shows signs of being very wet. There is a great deal of render missing on the front elevation. Many of the window lintels are failing and bowing into the street in imminent danger of collapse. One section seems to have lost its roof, and at the rear the temporary roof on one section looks as if it is beginning to fail. The building has a lot of plant life sprouting from the walls, roof and gutters. An original gold painted sign has been exposed and will soon be at risk.
